Condition Assessment  
&  
Reserve Fund Plan Update  
2018  
**REDWOOD LAKES**

Culpeper, Virginia

RE: **CONDITION ASSESSMENT AND RESERVE FUND PLAN UPDATE 2018**  
**Owners' Association at Redwood Lakes**  
Culpeper, Virginia  
Project No. 8585

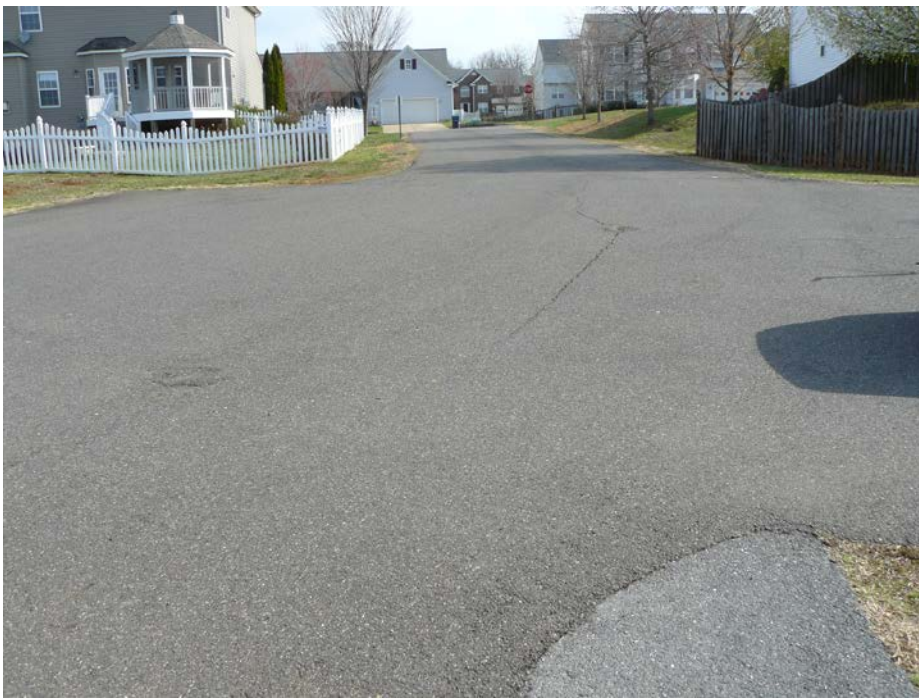
1.1	Asphalt Restoration Project	722	SY	\$14.50	\$10,469	20	2027	100%	\$13,074	2047	100%	\$21,424				This component includes the single asphalt driveline and parking area at the pavilion. The driveline and parking area layout do not include curbs and gutters or sidewalks. Neither the depth nor the sub-base of the pavement could be visually determined. We understand that the pavement was completed circa 2006, and it is in good condition. No areas of alligator cracking (indicative of sub-base damage or insufficient asphalt depth), but about 105 linear feet of cracking was observed. Restoration includes full-width milling and new compacted asphalt. Core sampling should be used to determine the depth and condition of the sub-base and pavement prior to restoration.

**PHOTO #1**  
The asphalt drivelane and parking area at the pavilion is in overall continuing good condition.

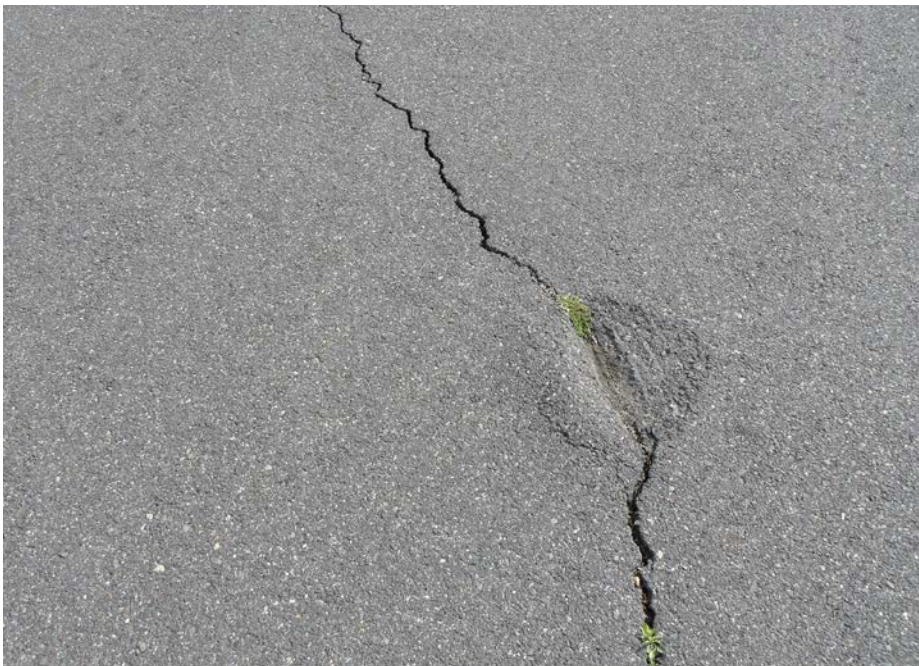
**PHOTO #2**  
Only a minor quantity of longitudinal and transverse cracking was observed.

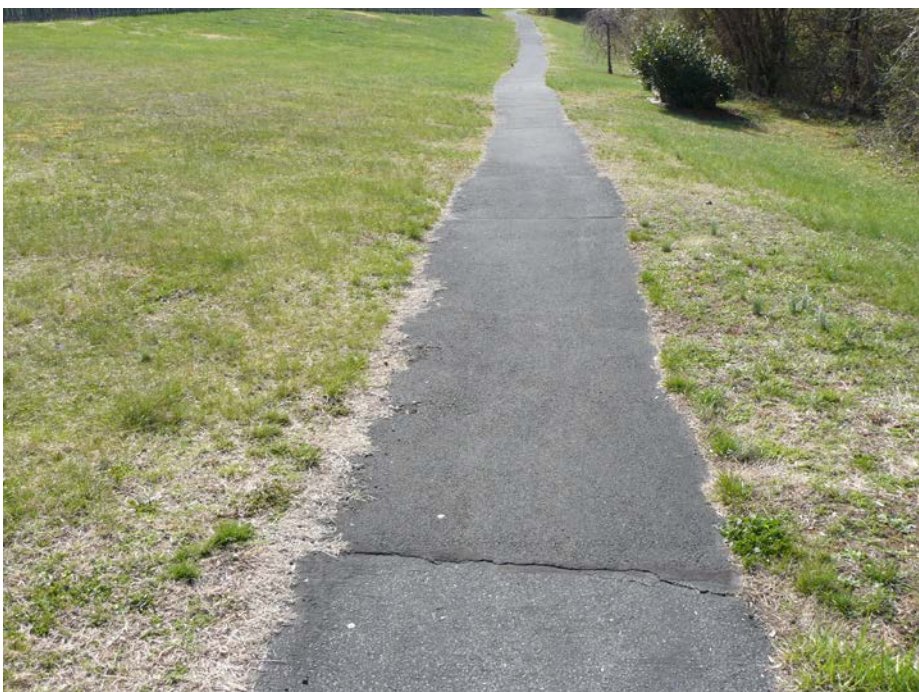
1.2	Asphalt Footpaths	1,389	SY	\$36.00	\$50,004	15	2021	100%	\$53,849	2036	100%	\$77,989	2051	100%	\$112,952	Asphalt footpaths generally 5' in width, are constructed from the pavilion parking area, along the lake, and ending on Windermere Drive. An additional footpath is constructed from the pavilion running east to the community property line. The footpaths range from fair to generally good condition with minor deflection and transverse cracking observed. Any trip hazards or surface deficiencies should be addressed as soon as practicable to prevent personal injury.
<b>2 CONCRETE COMPONENTS</b>

**PHOTO #3**  
The asphalt footpaths range from fair to generally continuing good condition. Some transverse cracking and minor deflection was observed.

**6.2 Asphalt Footpaths:** Transverse and longitudinal cracks should be cleaned of debris and plant growth (lanced) and filled with a rubberized asphaltic compound to prevent water infiltration. Cracks and deflection of the asphalt pavement can develop in the areas where tree roots cross the path. Tree roots should be removed and damaged areas repaired. An additional maintenance issue with footpaths is vegetation control. In areas where vegetation encroaches on the paths, both underfoot and overhead, visibility is reduced and personal injury can occur from low-growing branches. Vegetation control should be accomplished on a regular basis under the maintenance budget for safety considerations and to extend the useful service life of the pavement.

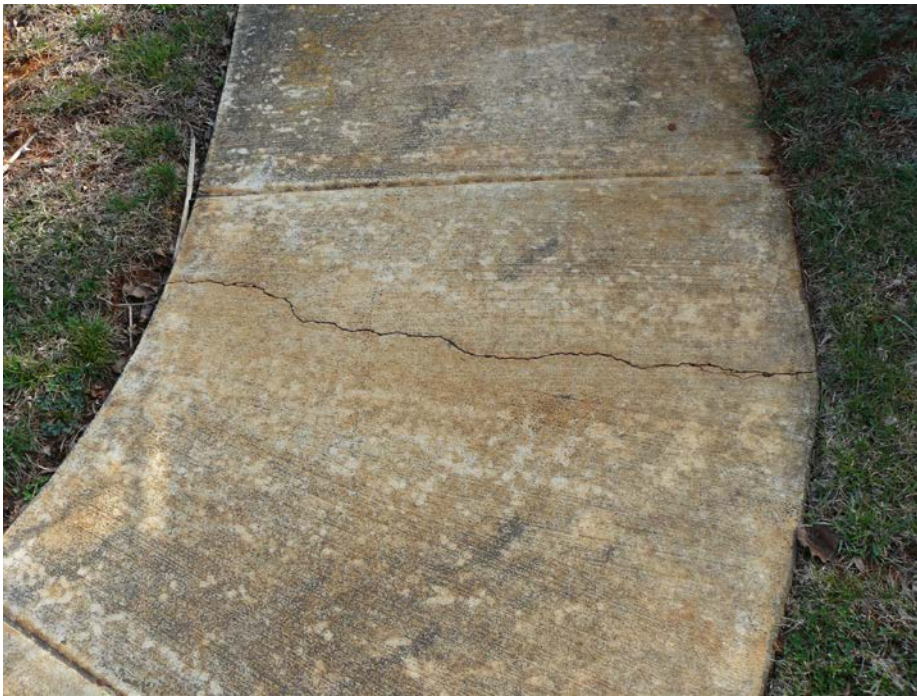
**PHOTO #4**

2.1	Concrete Sidewalk & Patio	1,468	SF	\$13.50	\$19,818	5	2020	25%	\$5,205	2025	25%	\$5,889	2030	25%	\$6,663	A single concrete sidewalk, generally 4' wide, is constructed between the pavilion and the asphalt parking area for accessibility. This category includes the concrete patio constructed as the pavilion base. Their thickness could not be visually determined. They are in generally good condition. We observed two minor cracks on the sidewalk panels and minor cracking of the patio. Cyclic repairs are scheduled, as full replacement at one time is not appropriate or anticipated. The Board should be aware that repairs to small quantities of concrete may be more costly because of the difficulty of attracting competitive bids for small projects, which may not meet contractor minimums. Any trip hazards or surface deficiencies should be addressed as soon as practicable to prevent personal injury.

The concrete sidewalk panels for the handicap access are in continuing good condition. Two minor cracks were observed.

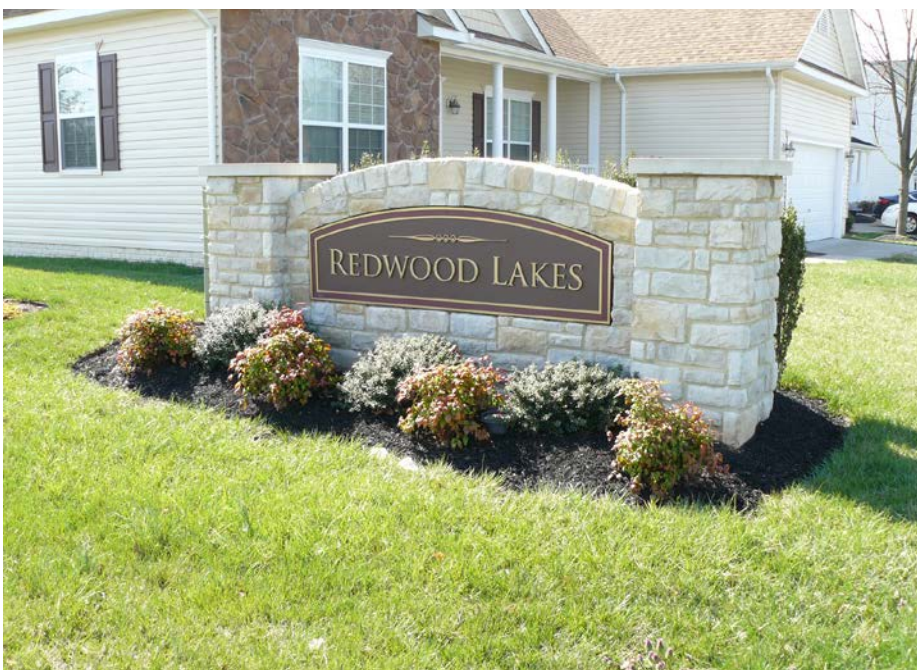
**PHOTO #5**

<b>3 SITE FEATURES</b>																
3.1	Entrance Monument	1	EA	\$13,000.00	\$13,000	30	2047	100%	\$26,603							A stone and mortar monument has been recently constructed at the entrance to the community. The monument has two 3' x 3' x 4' columns with cast concrete caps, with an 8' x 4' wall between the columns. A 7' x 3' MDF (Medium density fiberboard) community name sign is attached to the front of the monument. The monument and sign are in new condition. Pricing is based on actual cost, provided by Management. With periodic maintenance performed under the operations budget, the monument should have a very long service life.

A new entrance monument and sign was constructed recently, which is a nice addition to the community.

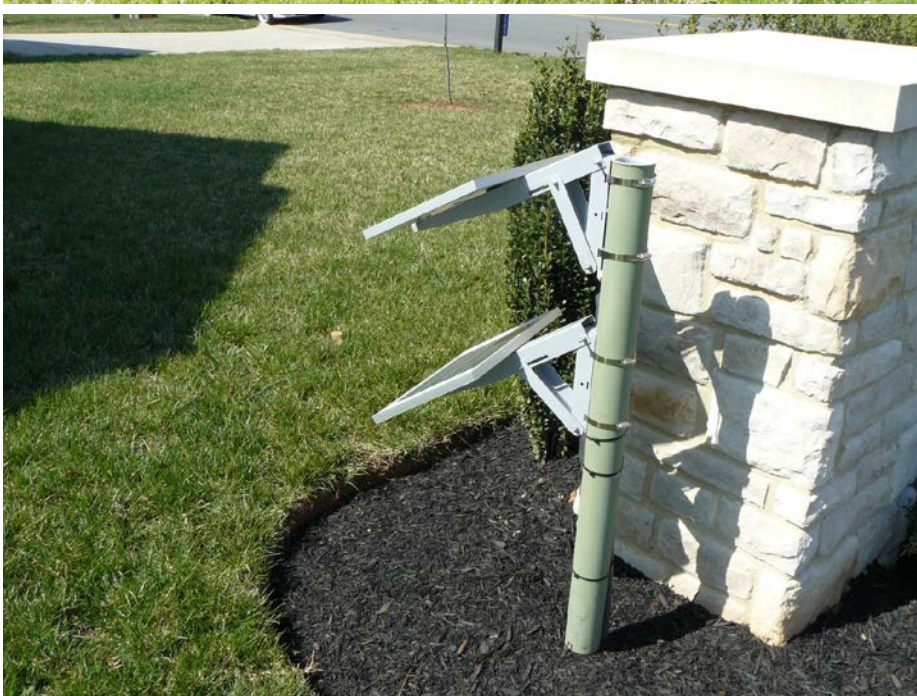
**PHOTO #6**

3.2	Monument Lighting	1	LS	\$1,100.00	\$1,100	10	2027	100%	\$1,374	2037	100%	\$1,759	2047	100%	\$2,251	Landscape lighting is installed at the entrance monument. The lighting includes two 5" oval L.E.D. lights powered by two 8" x 6" solar panels mounted next to the monument. We did not observe a battery box. Lighting appears to be in good condition, but was not observed after dark. Landscape lighting generally has a short service life due to the proximity to ground and moisture and damage from landscaping practices.

Solar panels provide power to the two oval L.E.D. lights, which provide nighttime illumination. Lighting was not observed after dark.

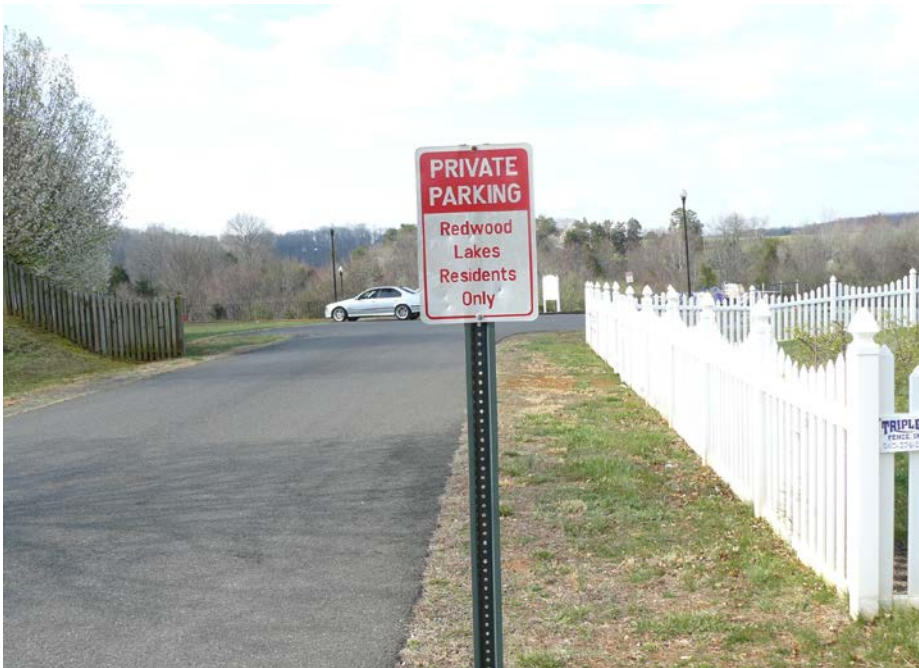
3.3	Informational Signage	3	EA	\$165.00	\$495	20	2027	100%	\$618	2047	100%	\$1,013				Standard metal access control signs, typically 12" by 18" and mounted on perforated metal posts, and a 2' x 4' plywood sign, mounted on 4 x 4 wood posts are installed at the pavilion parking area. Posts and signs appear to be in continuing good condition. Maintenance, such as repainting the wood sign and straightening the metal signs should be accomplished every few years.

**PHOTO #7**  
The three street and informational signs at the park are in continuing good condition.

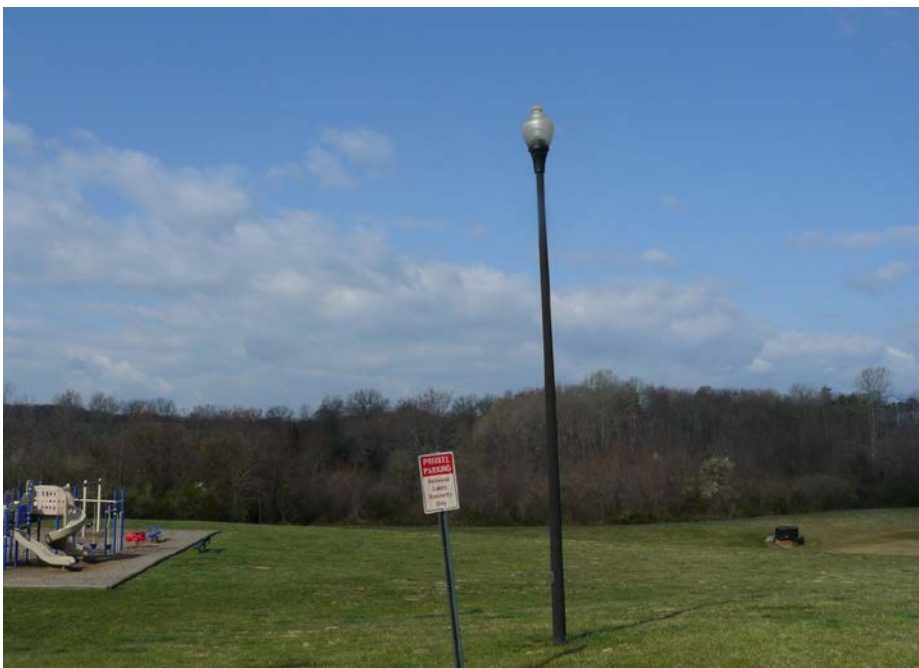
3.4	Light Poles & Fixtures	3	EA	\$2,800.00	\$8,400	30	2036	100%	\$13,101	2066	100%	\$27,481				Management advised that the community is responsible for maintenance and replacement of the three street lights installed at the pavilion. Three fiberglass reinforced plastic (FRP) light poles, about 20' high, with traditional lantern fixtures provide area illumination. They appear to be in generally continuing good condition. The lighting was not observed after dark. No problems were reported with lighting.

**PHOTO #8**  
The three pole lights at the park appear to be in continuing good condition. The poles appear to be slightly out of plumb and should be straightened. Lighting was not observed after dark.

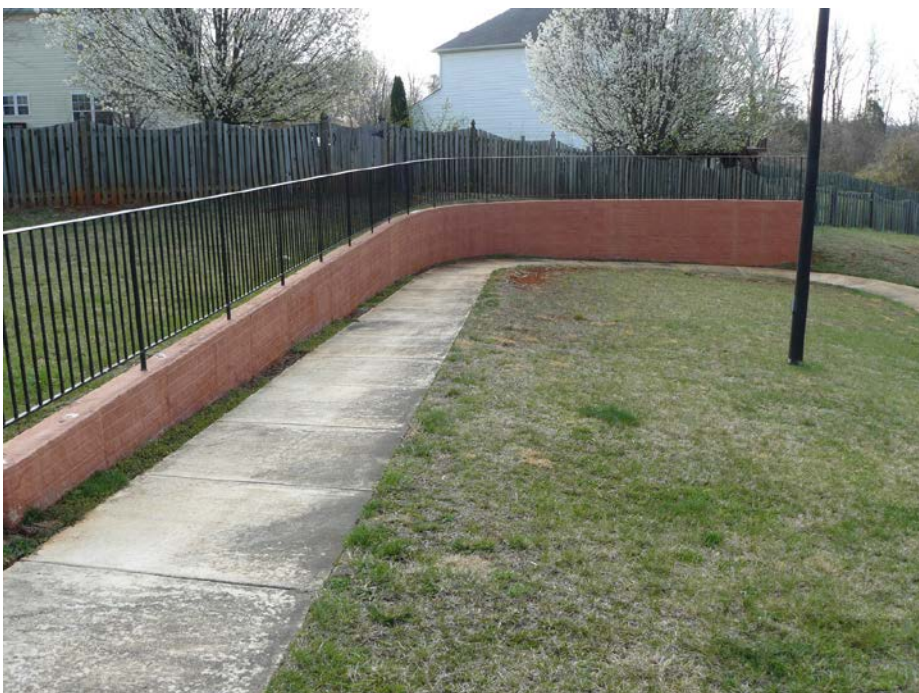
3.5	Concrete Retaining Walls	330	SF	\$55.00	\$18,150	40	2046	100%	\$36,236							Two cast-in-place, stamped concrete retaining walls are constructed at the grade differential above the pavilion. They appear to be in continuing good condition, with no major settlement cracking or deflection observed. Future repairs to the hand railing are included in Component #3.6 below. The service life of the walls are dependent on the railing bases being properly sealed to prevent water infiltration resulting in freeze/thaw damage. The walls have been painted, which has improved appearance.

**PHOTO #9**  
The concrete retaining walls have been painted, which is a major improvement over the previous rust staining. No major cracking was observed.

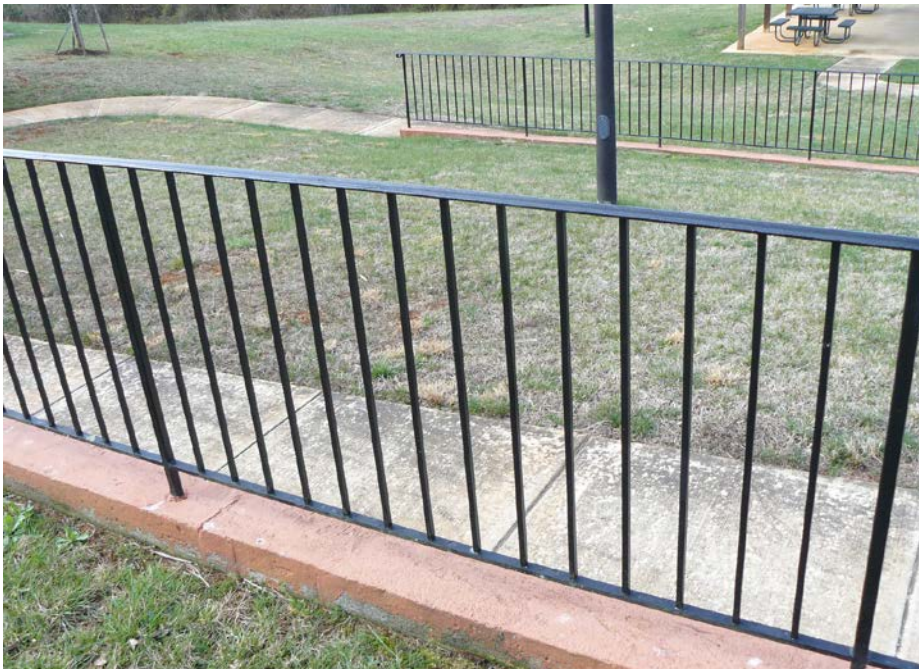
3.6	Metal Railing	110	LF	\$38.00	\$4,180	30	2036	100%	\$6,519	2066	100%	\$13,675				Two painted steel railings, 3'-6" high, are attached along the top of the concrete retaining walls at the pavilion. The railings are in continuing good condition. They are integral to the retaining wall system, and restoration of the retaining walls will require removal. With proper, diligent maintenance, including cleaning of peeling paint, priming, and painting, and repairing deteriorated areas by welding replacement parts, the railings may be reusable, and may have a long service life.

embedded posts pockets are filled, will help maximize the service life.

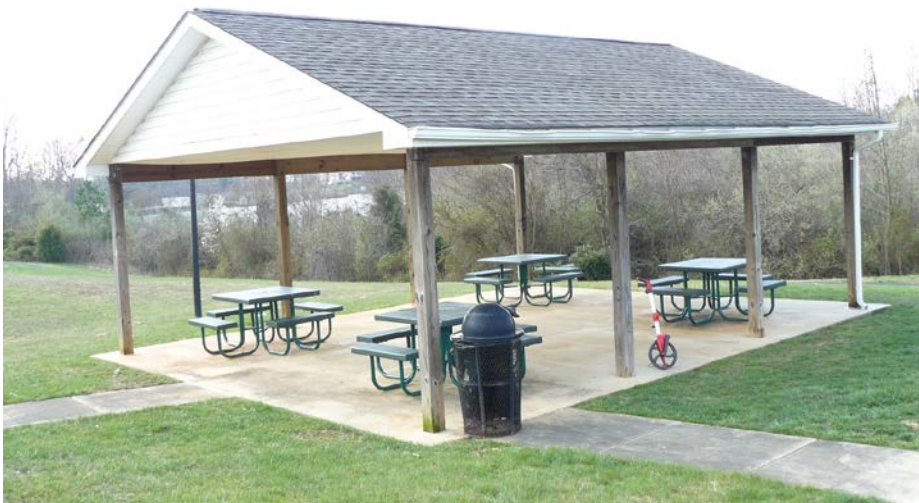
3.7	Pavilion Re-Roofing Project	672	SF	\$5.75	\$3,864	20	2025	100%	\$4,593	2045	100%	\$7,526				A wood framed pavilion was constructed at the common area circa 2006. Eight wood posts support the roof structure and painted plywood ceiling over a concrete slab floor. The pavilion measures 28' x 24' with a 6/12 pitched roof and architectural grade asphalt shingles. The structure, roof sheathing, and the shingles appear to be in continuing good condition. Gutters are properly attached to the structure and direct water away from the building. This component is for eventual roofing replacement and possible gutter refurbishment. We understand that the gazebo will have near-term minor repairs and cleaning.

**PHOTO #11**  
The gazebo roofing, outdoor furniture, and the patio range from fair to generally continuing good condition. Some cracking of the concrete patio floor was observed.

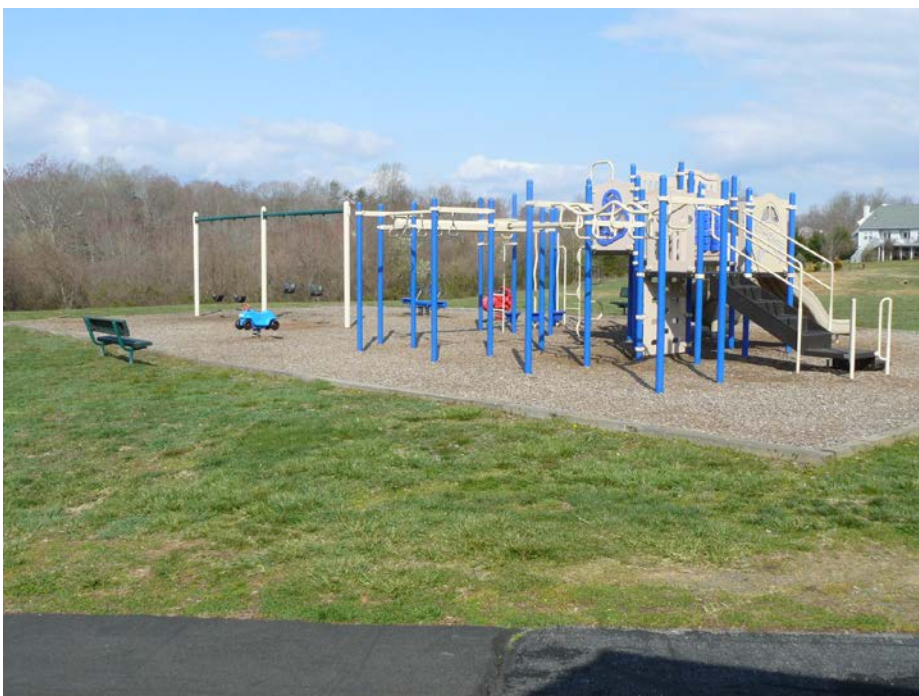
3.8	Tot Lot & Outdoor Furniture	1	LS	\$42,000.00	\$42,000	18	2024	100%	\$48,707	2042	100%	\$75,966				One tot lot is located at the pavilion. Equipment consists of 228 linear feet of wood borders, two plastic and metal benches, one trash receptacle, a three post swing set with four swings, and a Playcraft Systems, 26 metal post play module with climbing equipment and two plastic slides. All equipment appears to be in continuing good condition. This category also includes the four plastic and metal picnic tables and the trash receptacle at the pavilion. Frequent, periodic safety checks of all components should be conducted to prevent personal injury. Replacement costs are based on replacement with U.S. Consumer Product Safety Commission (CPSC)-compliant play modules.

**PHOTO #12**  
The play module, swings, spring toys, and outdoor furniture are in continuing good condition.

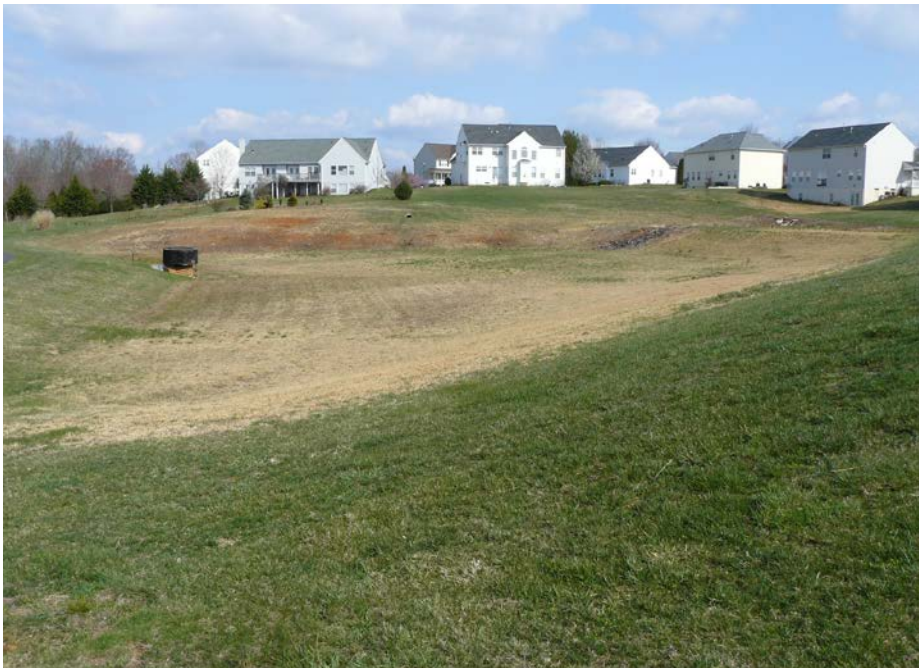
**PHOTO #13**  
The bottom detention pond (#5) has been mowed and is clear of vegetation.

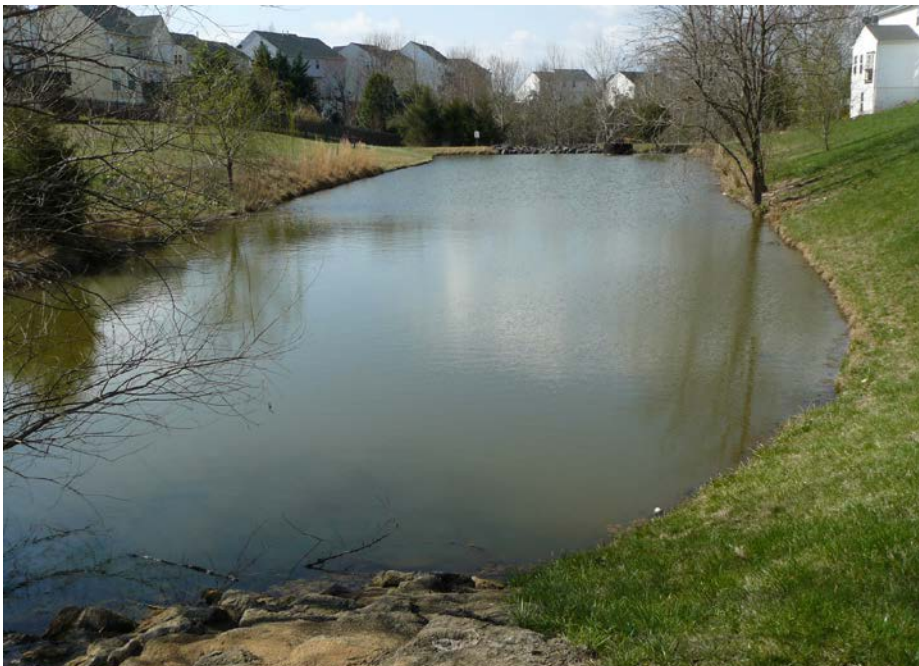
**PHOTO #14**  
The two upper retention ponds appear to be in continuing good condition. These ponds should have an evaluation to determine sediment levels and overall pond health.

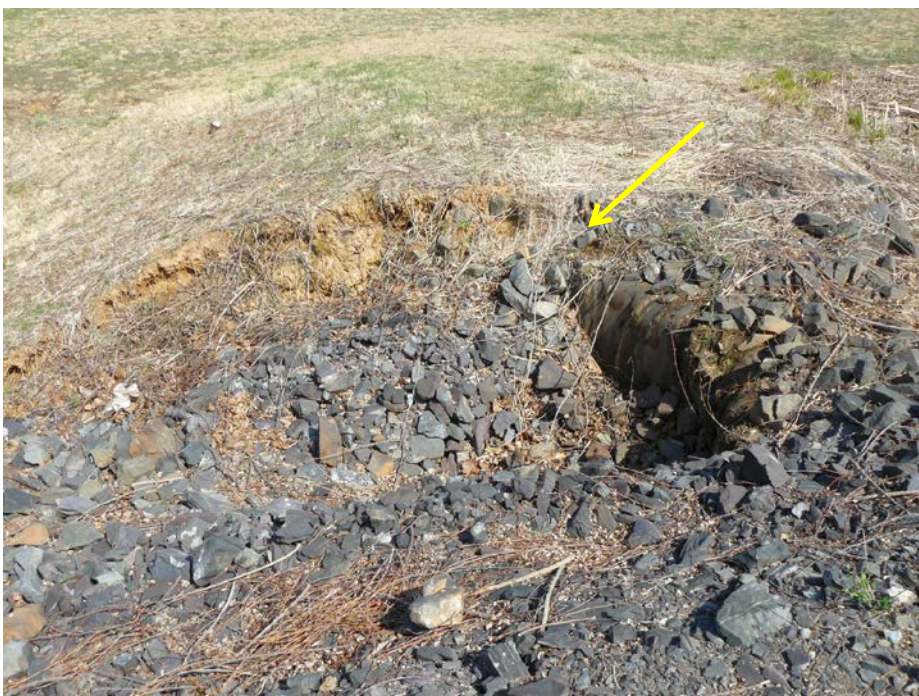
**PHOTO #15**  
There appears to be heavy erosion between detention pond #4 and pond #5, which should be repaired.
