Condition Assessment Reserve Fund Plan 2015 *THE RESERVE AT MOORHEAD*

MASON & MASON

RE: CONDITION ASSESSMENT AND RESERVE FUND PLAN 2015 The Reserve at Moorhead Homeowners Association Warrenton, Virginia Project No. 7802

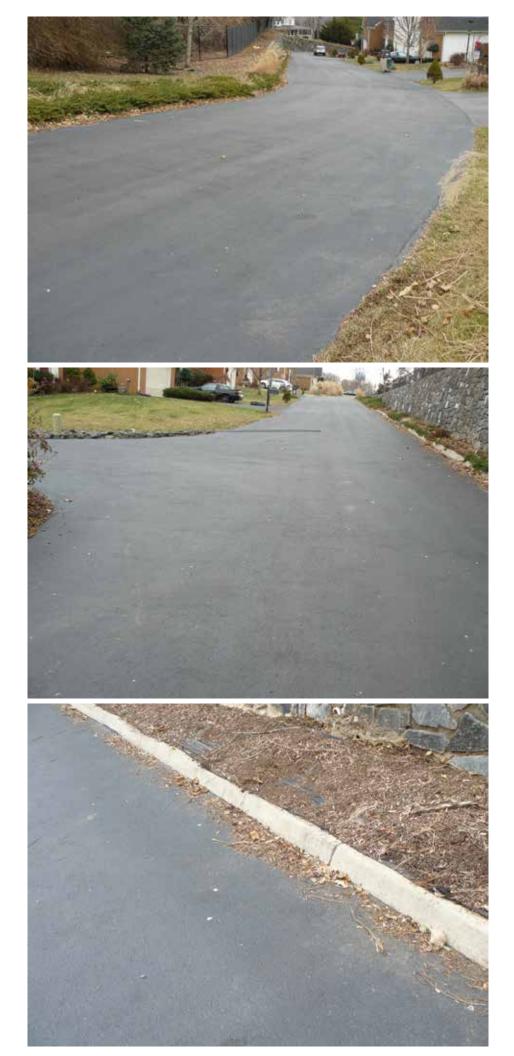
PHOTO #1 The asphalt pipestem at the end of Preston Drive appears to be in good condition.

PHOTO #2 We understand that the pipestem received seal coating around 2014. We did not observe any deflecting, transverse, or longitudinal cracking.

The pipestem is lined on one side with a single concrete curb. This will require the next restoration project to include edgemilling, to prevent a loss of height at the curb during the next overlay.

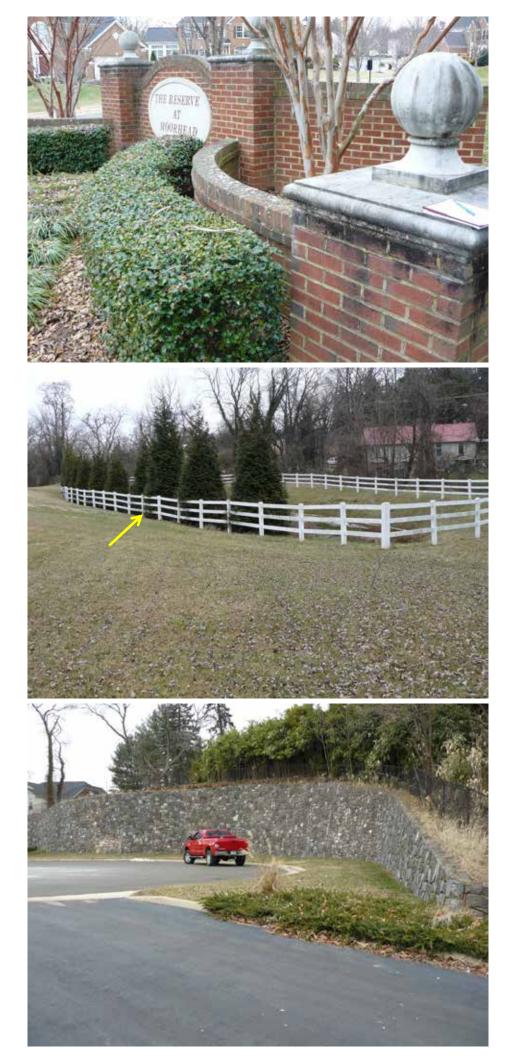
PHOTO #4

The brick and mortar entrance monument is in good condition. The monument should receive periodic appropriate masonry cleaning to improve appearance.

The vinyl fencing installed around the detention pond is in good condition. Pressure washing will help to maintain its appearance. The trees against the fencing should be trimmed to prevent future deflection of the fencing.

PHOTO #6 The stone retaining wall appears to be in good condition. We did not observe any major cracking or settlement.

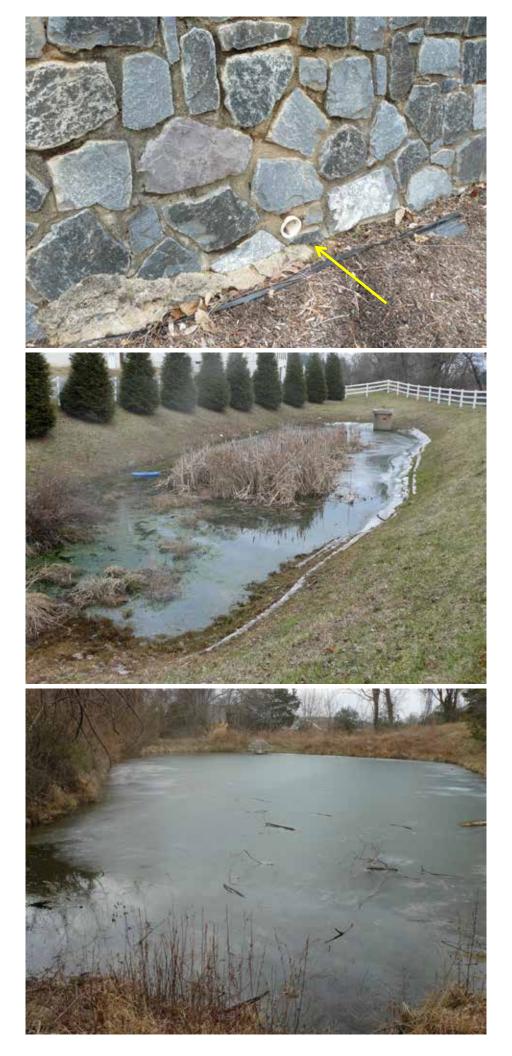
PHOTO #7

The wall appears to be properly constructed with weep (drainage) holes at the bottom of the wall. This will reduce hydrostatic pressure and contribute to a long service life.

The storm water retention pond on the east side of the community could become problematic in later years, if conditions allow for sediment build-up resulting in the need for dredging. Vegetation around this pond should be cleared and kept clear.
