Condition Assessment
and
Reserve Fund Plan
2013

*WHITES
MILL*

Warrenton, Virginia

RE: **CONDITION ASSESSMENT AND RESERVE FUND PLAN 2013**
Whites Mill Homeowners' Association
Warrenton, Virginia
Project No. 7338

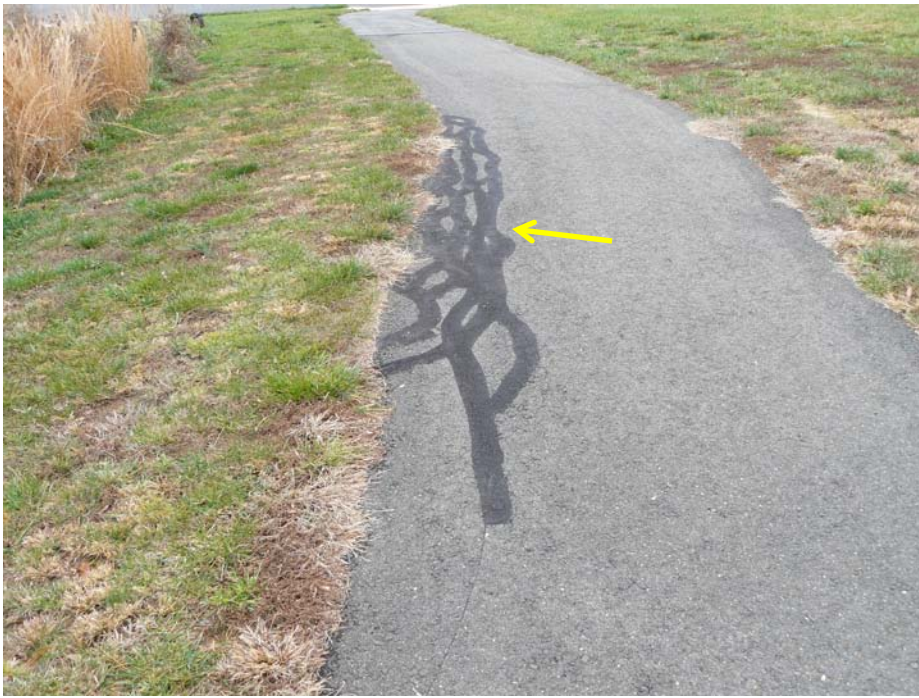
PHOTO #1

The footpaths are in good condition. Minor edge cracking was observed on both asphalt footpaths. Some sections of the footpaths have received recent crack filling maintenance.

6.1 Asphalt Footpaths: Transverse and longitudinal cracks should be cleaned of debris and plant growth (lanced) and filled with a rubberized asphaltic compound to prevent water infiltration. Cracks and deflection of the asphalt pavement can develop in the areas where tree roots cross the path. Tree roots should be removed and damaged areas repaired. An additional maintenance issue with footpaths is vegetation control. In areas where vegetation encroaches on the paths, both underfoot and overhead, visibility is reduced and personal injury can occur from low-growing branches. Vegetation control should be accomplished on a regular basis under the maintenance budget for safety considerations and to extend the useful service life of the pavement.

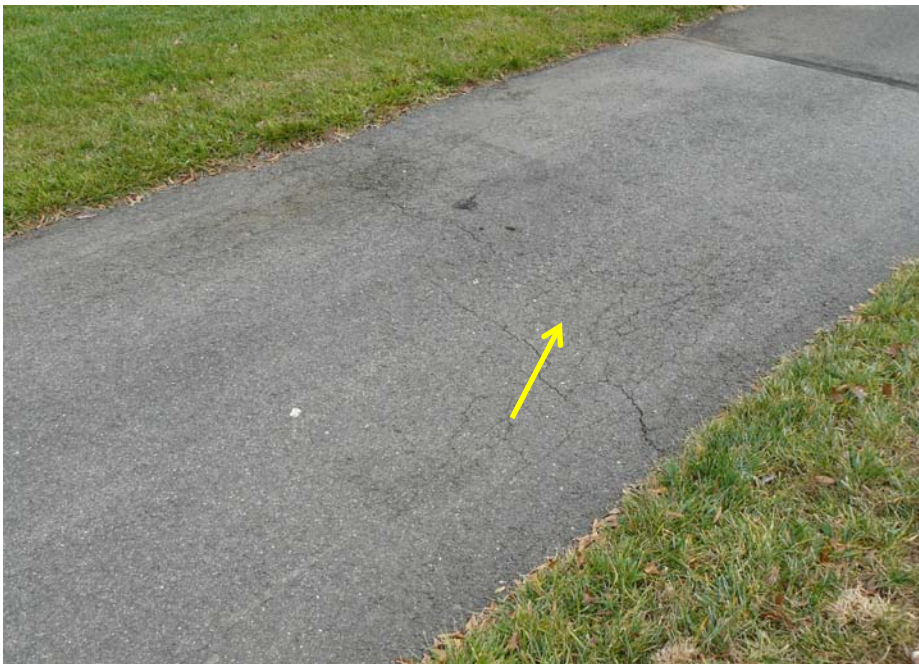
PHOTO #2

A minor amount of deflection was observed on the lower footpath. Asphalt maintenance, such as full-depth repair and crack filling should continue under the Operations budget.

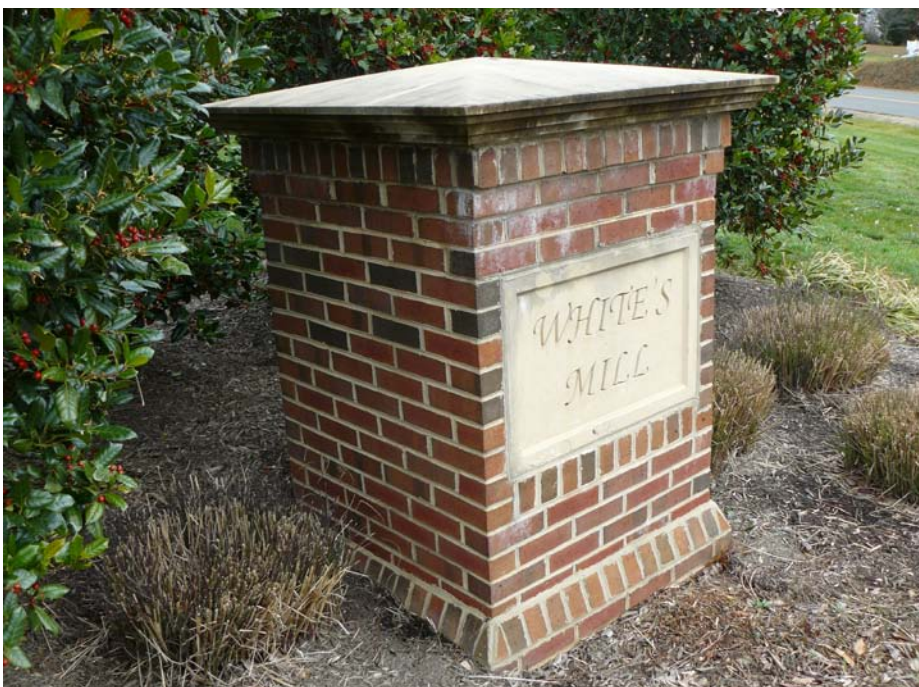
PHOTO #3

The four brick and mortar entrance monuments are in good condition. Tuckpointing the mortar may be necessary in the future.

6.2 Brick Entrance Monument: Brick monuments should be inspected periodically for step cracks in the mortar and shear cracks through the brick and mortar, indicating settlement problems. Signs of efflorescence on the brick face and mortar or spalling brick faces should be investigated. Efflorescence, a residue of fine white crystals resulting from salts leaching from the mortar, serves as a warning that water is infiltrating the structure. Water infiltration problems are usually initiated at the top of an improperly sealed coping. Eliminating the infiltration of water into the monument from the coping can be accomplished by various methods, depending on the brick detail. Installation of a metal coping is sometimes a cost-effective method of solving these problems and extending the life of the brick structure. Sealing of brick surfaces with breathable coatings will also extend the useful service life of the brick. All vegetation, such as vines or tree limbs should be kept clear of the monument to prevent damage. As brick components age, depending upon the initial quality of the mortar and the long-term environment of the monument, mortar joints may deteriorate. This condition can be corrected by tuckpointing. Applying soft sealants to the deteriorated joints or to cover up mortar joint cracks is not recommended. Deteriorated or cracked mortar joints should be repaired by cutting damaged material $\frac{3}{4}$ -inch deep with a diamond blade masonry saw. The void should then be filled with new mortar and the joints struck to match the original work

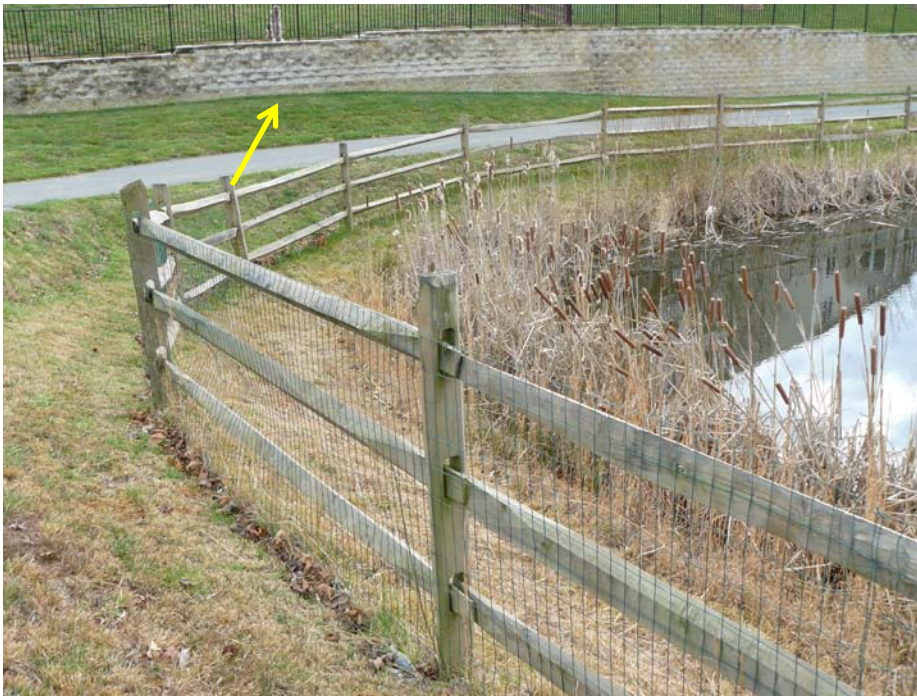
PHOTO #4

We understand that the modular block retaining walls and metal fencing at the lower retention pond are on private property, and that the individual homeowners are responsible for maintenance and replacement.

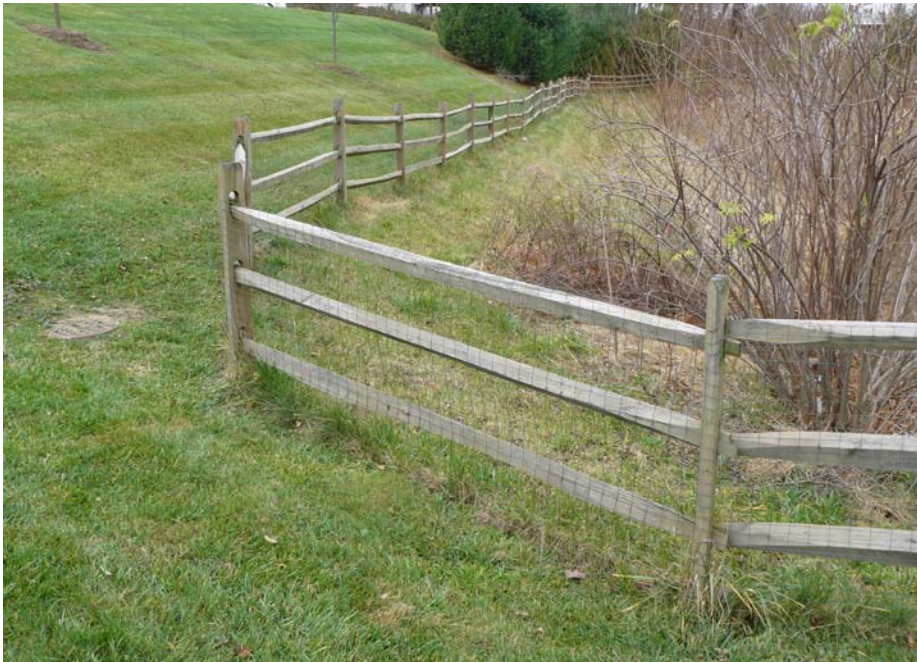
PHOTO #5

The pressure-treated split rail fencing installed around both of the ponds is in good condition. We have included the field wire in their replacement cost.

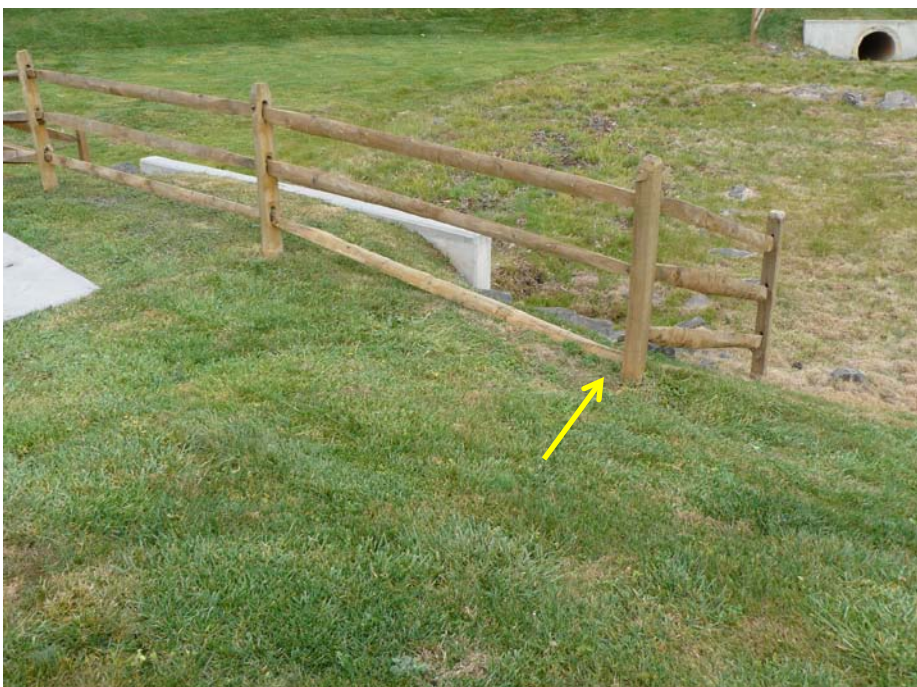
PHOTO #6

A few of the split rail horizontal timbers are not attached. The timbers may require replacement, as some are deflected and may not reach the bearing surface for secure reattachment.

6.5 Wood Fence: Bare wood components, both non-treated and pressure-treated, generally will achieve a greater useful service life and improved appearance if preventative maintenance is performed. Periodic pressure washing and sealing with wood preservative is recommended on all wood components. Rough edges and splinters should be sanded prior to sealing. Damaged or deteriorated wood components should be replaced as necessary. Generally, securing or repairing wood components with screws will provide a better fastening method than nails.

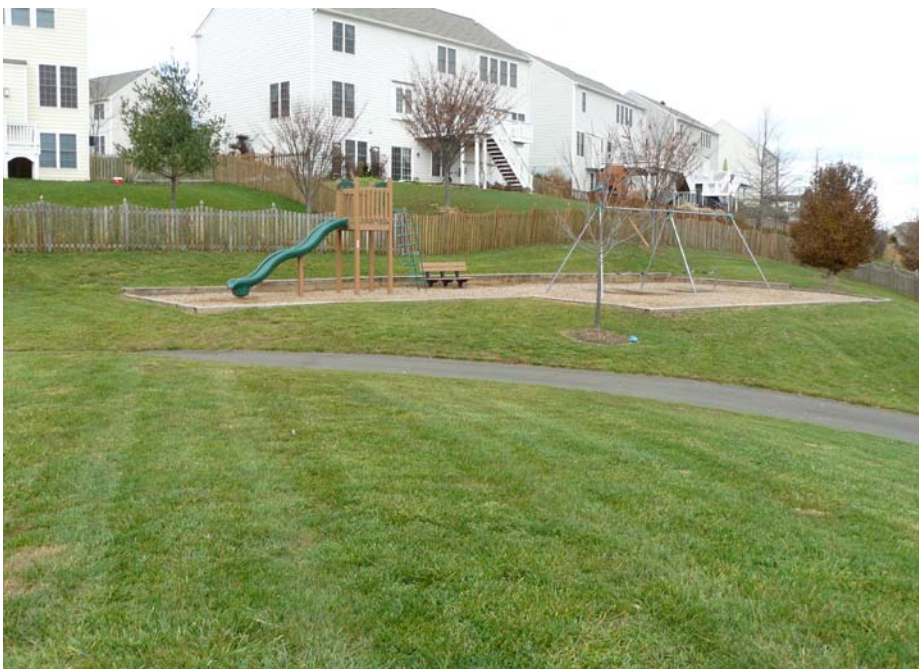
PHOTO #7
The Earthscapes Structures slide, the swing set, the wood borders, and the bench are in good condition. Frequent, periodic safety checks of all components should be conducted to prevent personal injury.

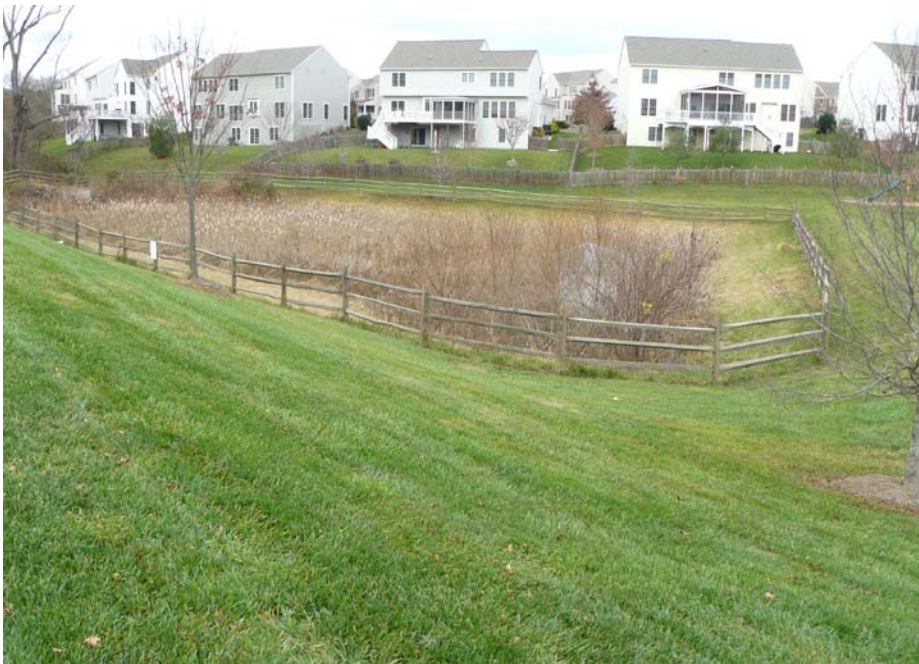
PHOTO #8
Heavy vegetation was observed in the upper detention pond. The vegetation should be removed and kept clear, so the design capacity of the pond is not diminished.

6.7 Storm Water Retention Ponds: Vegetation control in ponds and on adjacent banks is required to prevent root damage to the earthen structures. Sedimentation problems can result in dredging requirements to maintain capacity of the pond in the long term. Pond sediment levels should be monitored to establish the rate over a multi-year period. The information would be helpful in determining future reserve funding for dredging if found to be necessary. Inflow and outflow structures should be periodically inspected for damage, leaks, or deterioration, and cleaned of debris to prevent clogging.

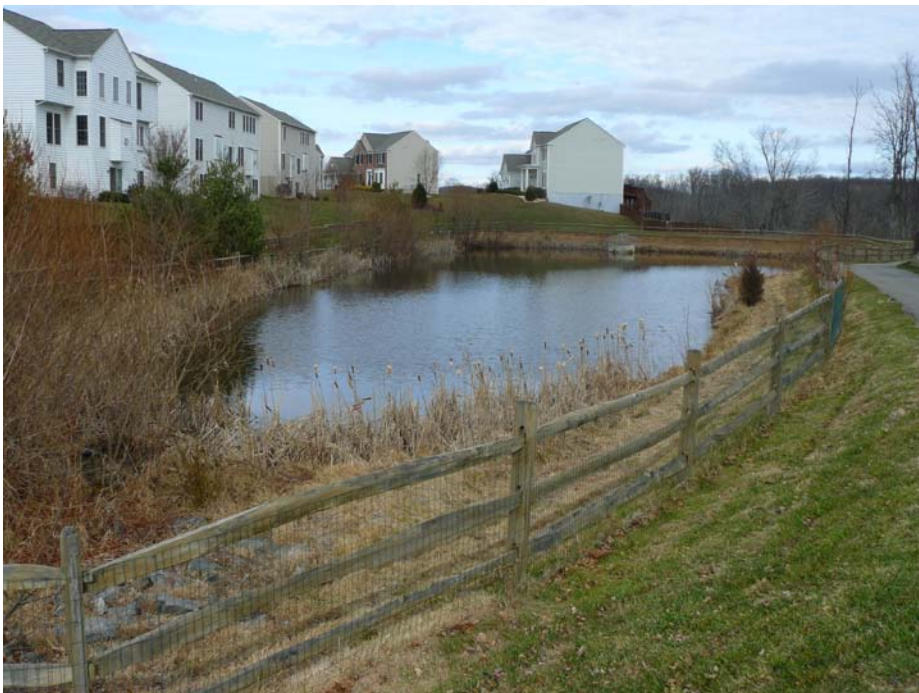
PHOTO #9
The lower retention pond appears to be in good condition. Vegetation should be kept clear from the pond. Sedimentation levels and water quality should be monitored.
