Condition Assessment
&
Reserve Fund Plan Update
2017

WHITES MILL

Warrenton, Virginia

RE: **CONDITION ASSESSMENT AND RESERVE FUND PLAN UPDATE 2017**
Whites Mill Homeowners' Association
Warrenton, Virginia
Project No. 8189

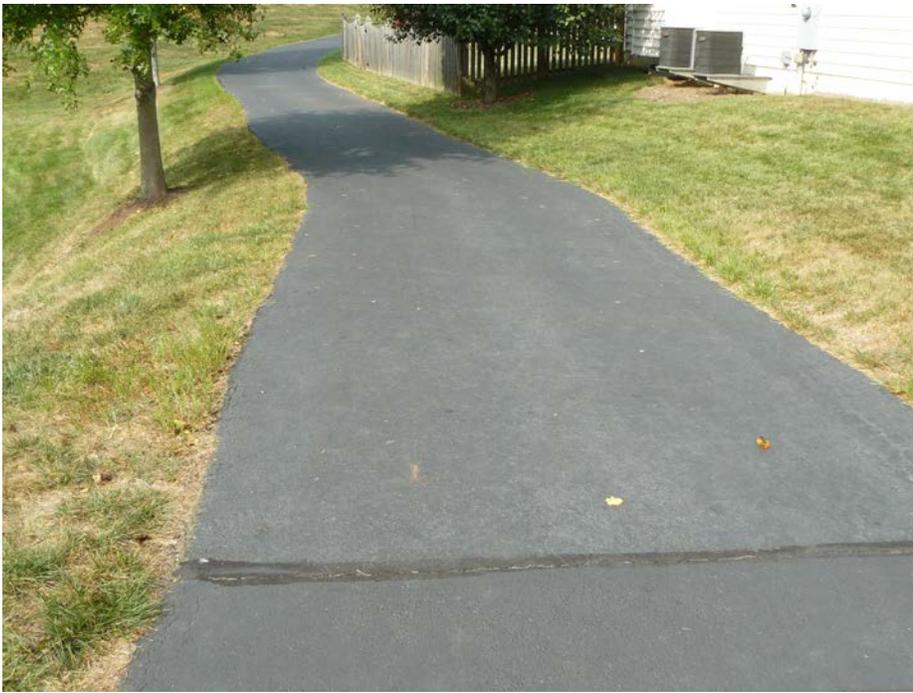
PHOTO #1
The asphalt footpaths are in continuing good condition. Only a very minor amount of deflected pavement was observed.

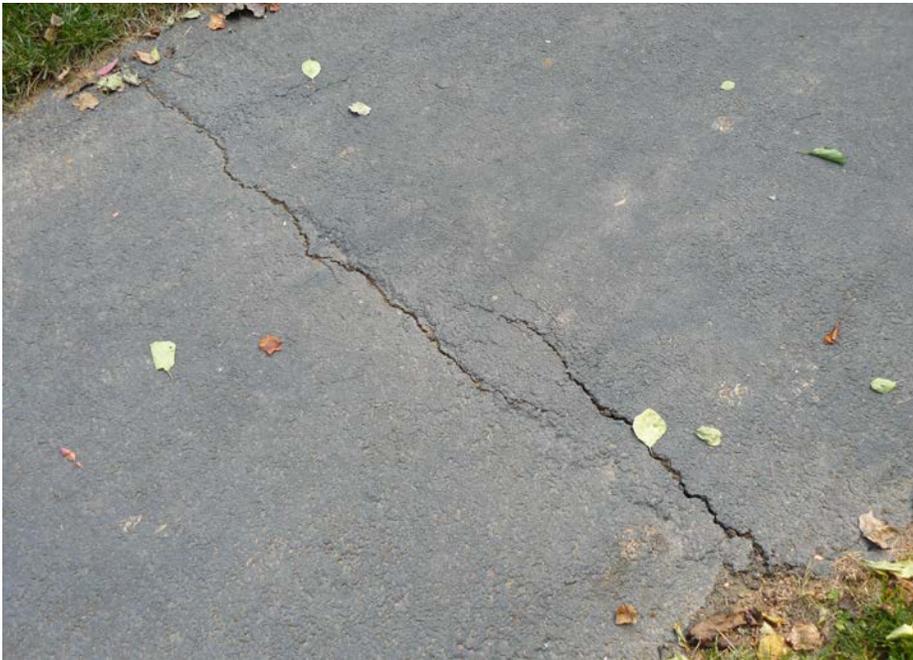
PHOTO #2
The footpaths have been crack filled in the past and recently seal coated. A minor amount of non-filled longitudinal and transverse cracking was observed.

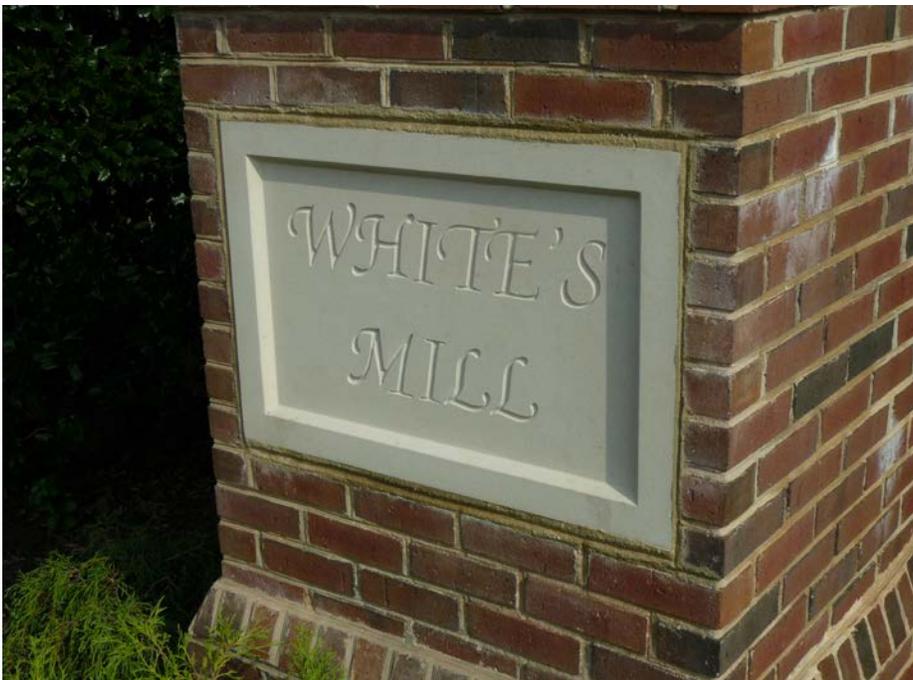
PHOTO #3
A community name sign has been installed on the left entrance monument since our previous site visit.

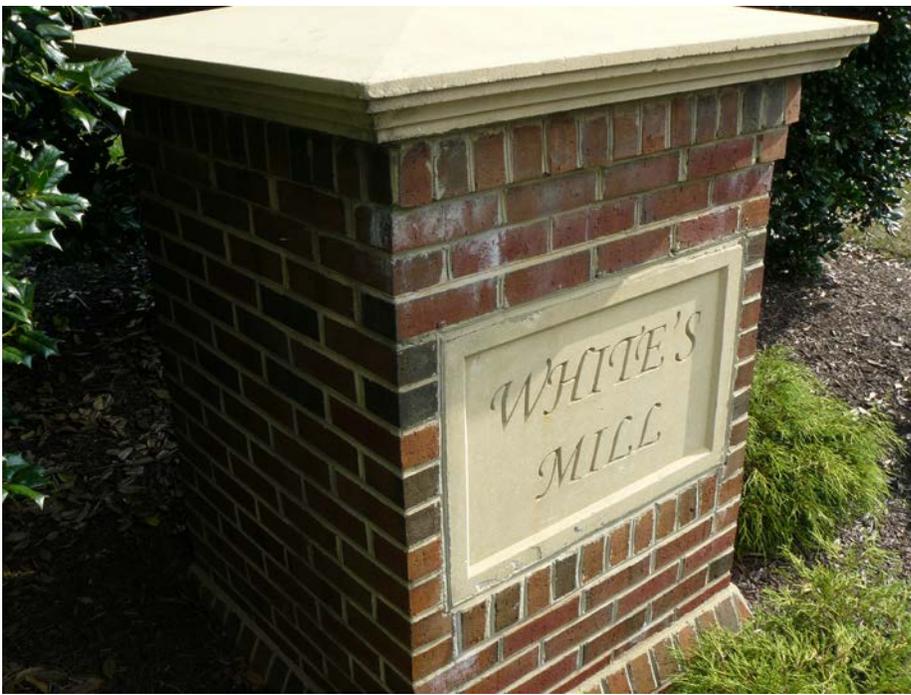
PHOTO #4

The right side community name sign is in fair to continuing good condition. Minor deterioration was observed of the sign, but the monuments are in continuing good condition.

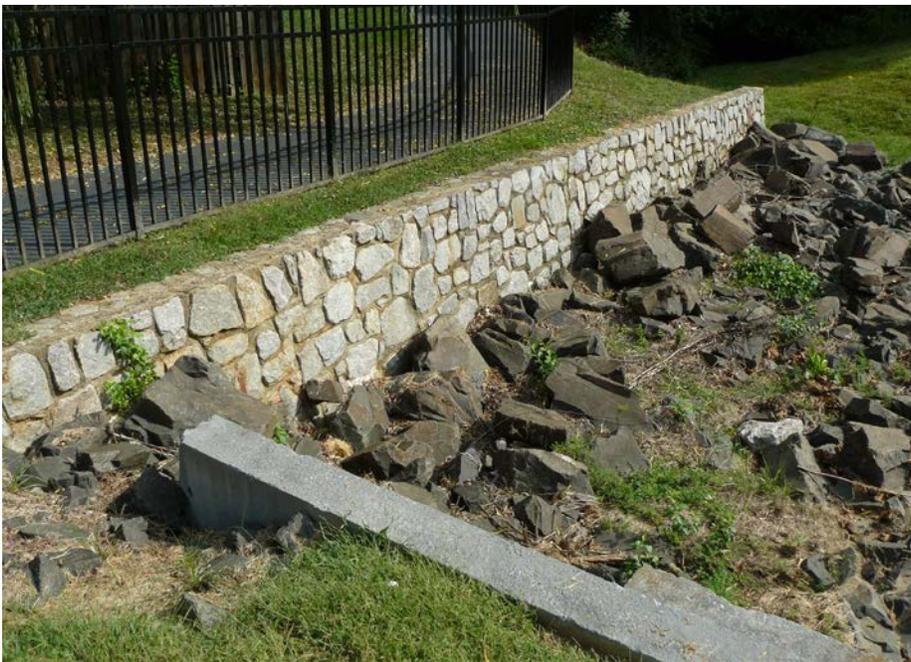
PHOTO #5

2.2	Stone Retaining Wall	200	SF	\$97.00	\$19,400	40	2045	100%	\$38,732							A mortared stone retaining wall is constructed near the top of the asphalt footpath near 7679 Movern Lane. It appears to be in continuing good condition with no cracking or deteriorated mortar observed. The community should schedule periodic tuckpointing at the top of the wall. The steel railing was removed from the wall and a new larger section of fencing was installed behind it. The previous post pockets should be filled with mortar to prevent water infiltration into the wall resulting in freeze/thaw damage.

The stone and mortar retaining wall is in continuing good condition. The metal railing installed on this wall has been removed. Tuckpointing of the top of this wall should continue.

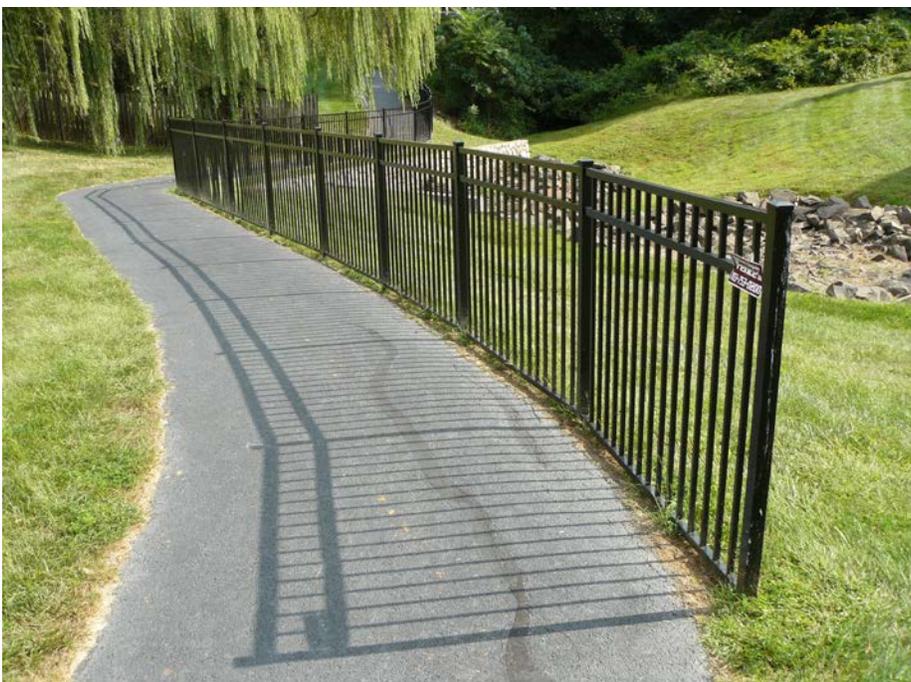
PHOTO #6

Metal fencing, installed by Northern Virginia Fence Company has replaced the metal railing at the retaining wall.

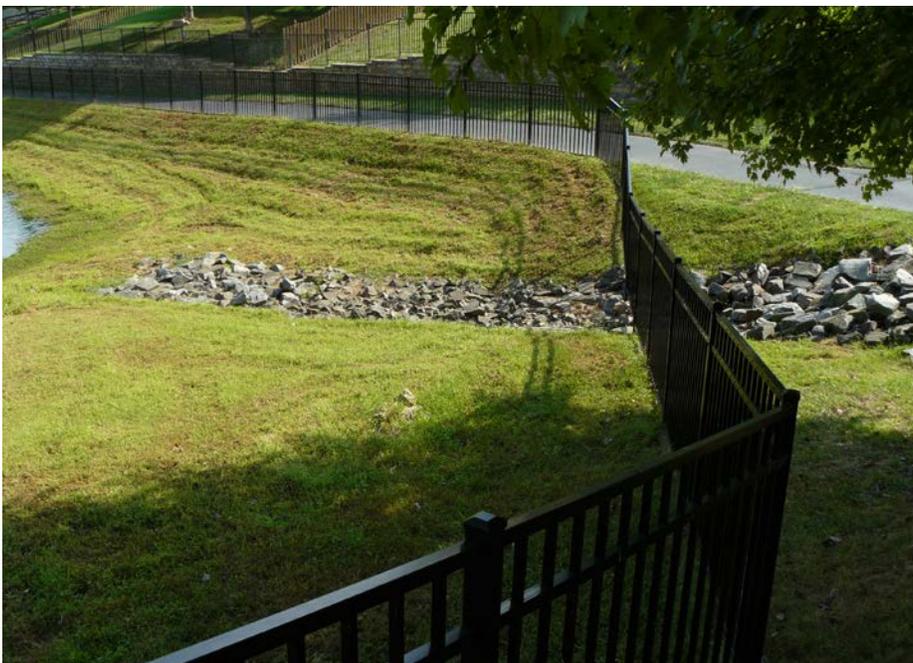
2.3	Metal Fencing	1,548	LF	\$22.00	\$34,056	30	2045	100%	\$67,993							Painted aluminum fencing, 4' high is secured in the ground, behind the stone retaining wall along the footpath and at each area where the wood split-rail fencing was removed. This includes new fencing installed at both ponds and at the tot lot. All fencing was installed around 2014. With proper, diligent maintenance, including cleaning of peeling paint, priming, painting, and repairing deteriorated areas by welding replacement parts, this fencing may be reusable and may provide a very long service life. Pricing is based on invoices provided by Management.

PHOTO #7
All pressure-treated wood fencing has been replaced by metal fencing throughout the community, which is a much-improved alternative, and should provide a long service life.

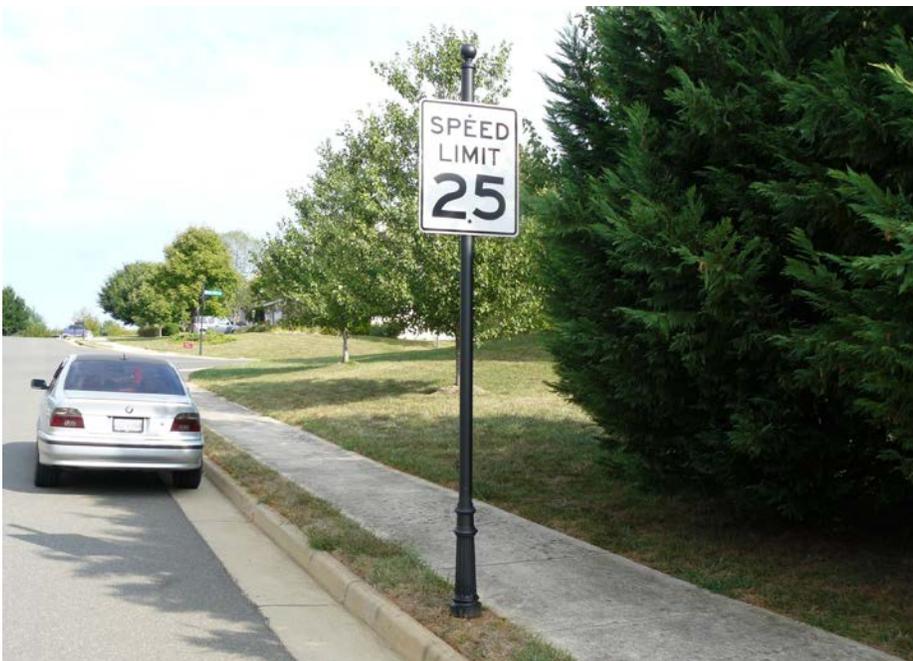
2.4	Street Signage	1	LS	\$12,000.00	\$12,000	15	2030	100%	\$16,542	2045	100%	\$23,958				The community had approximately 13 custom signs installed throughout Whites Mill by Mid-Atlantic Mailbox, Inc. circa 2014. The signs included stop, speed limit, county markings, and street names. These are heavy duty, 'breakaway' signs with black paint, some with ball finials. They are in excellent condition and are a nice addition to the community. Pricing is based on invoices provided by Management.

PHOTO #8
All posts and signs have been replaced with custom poles and signs about 2014.

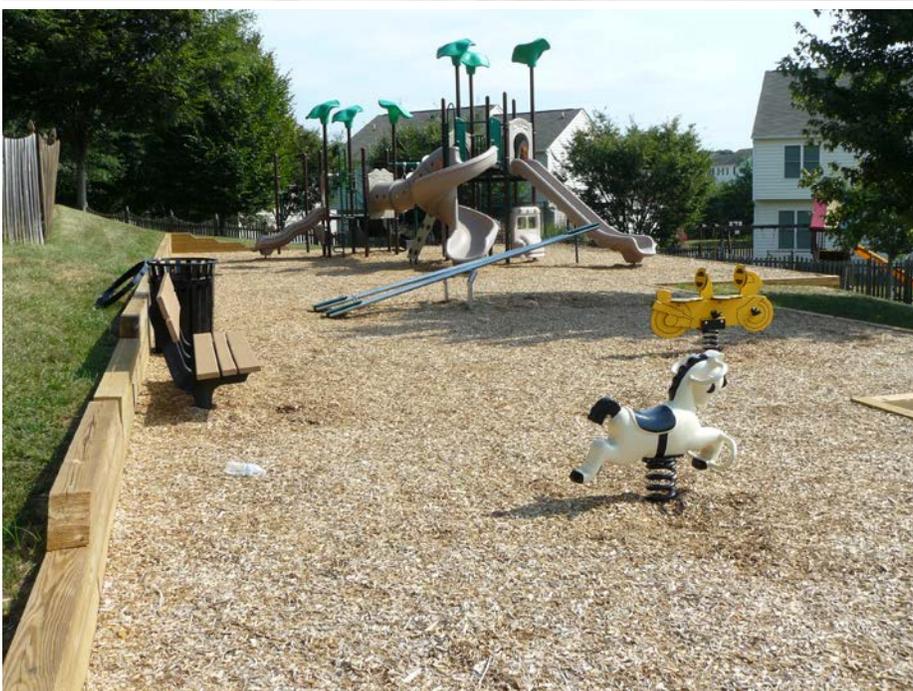
2.5	Tot Lot & Outdoor Furniture	1	LS	\$40,000.00	\$40,000	15	2032	100%	\$57,932	2047	100%	\$83,903				One tot lot is located at the center of the community. The tot lot was completely renovated circa 2015. Equipment now consists of 243 linear feet of wood borders with a small retaining wall, one bench, one trash can, two spring toys, a see-saw, and a Carrot Crop, 16 post play structure with three slides. All equipment appears to be in new condition. One end of the see-saw was not seated properly, which should be repaired. Frequent, periodic safety checks of all components should be conducted to prevent personal injury. Replacement costs are based on replacement with U.S. Consumer Product Safety Commission (CPSC)-compliant play modules, and based on invoices provided by management.

PHOTO #9
The tot lot has been completely renovated in recent years. This included replacement of the wood border, retaining wall, and addition of spring toys, see-saw, and the new play module. The wood chip base appears to be an adequate depth.

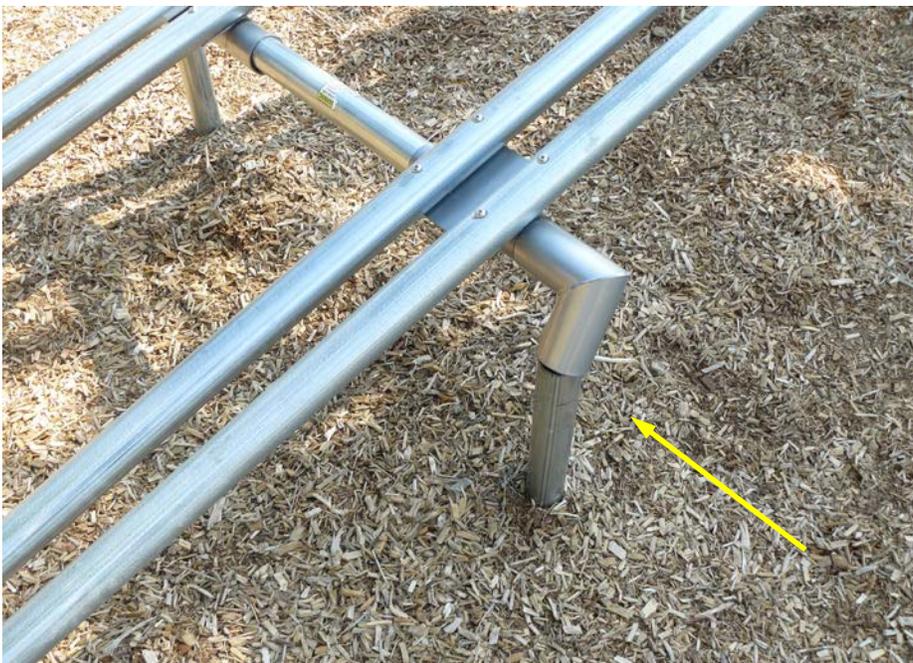
PHOTO #10
The see-saw leg is deflected, requiring repair. Once put into place, a bolt or pin should be added to secure the legs.

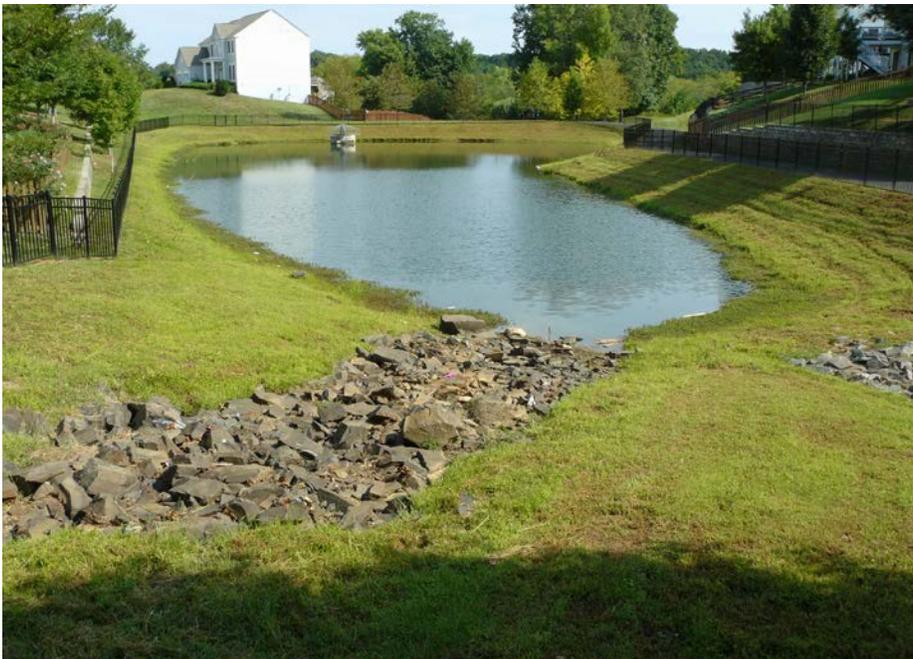
PHOTO #11
The storm water retention pond appears to be in continuing good condition. It is being properly mowed and vegetation is under control.

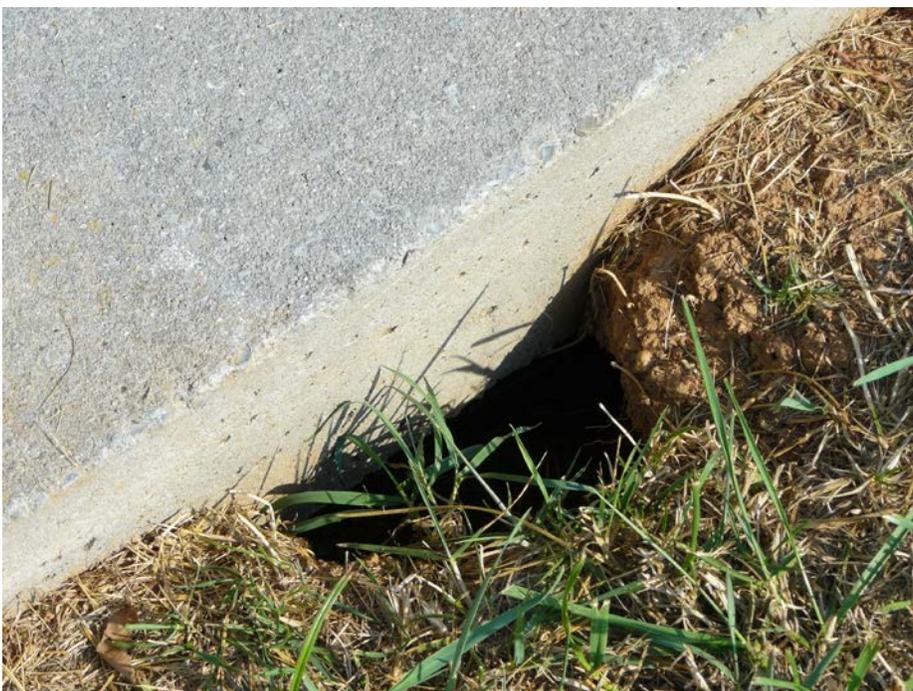
PHOTO #12
One area of erosion was observed next to the storm drain between the detention pond and Movern Lane, which should be repaired.
