(Final Report, Revised January 31, 2023) Condition Assessment & Reserve Fund Plan Update 2022

RESERVE AT JAMISON'S FARM Warrenton, Virginia

RE: CONDITION ASSESSMENT AND RESERVE FUND PLAN UPDATE 2022 Reserve at Jamison's Farm (Final Report, Revised January 31, 2023) Warrenton, Virginia Project No. 9624

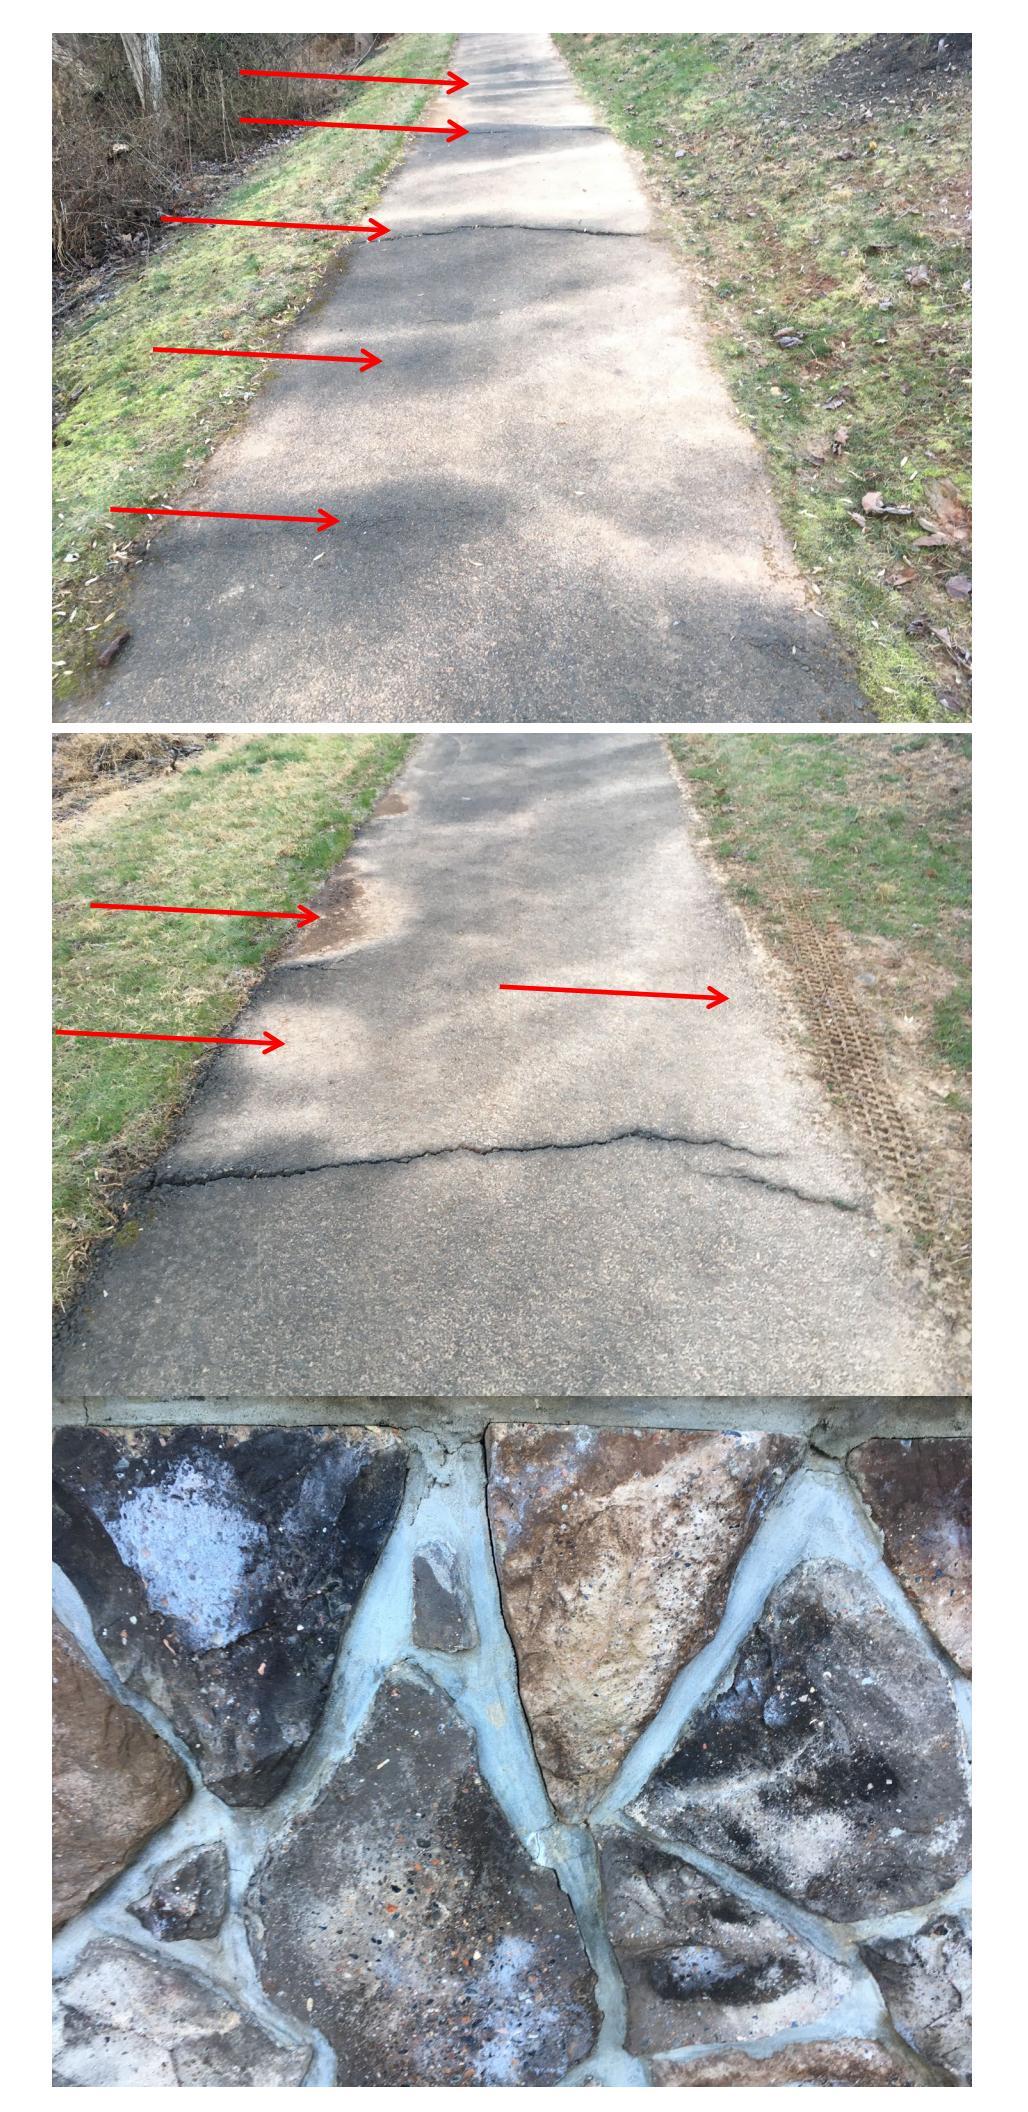
PHOTO #1

The asphalt footpath appeared to be in fair condition. We observed multiple areas of asphalt heaving (red arrows) due to nearby trees growing out of place. These areas might form potential tripping hazards and should be mitigated expeditiously to prevent personal injury.

We also observed approximately 90 feet of linear cracking. The color of the pavement suggested the path has issues with ponding (red arrows), which might potentially cause slipping hazards. If present, such hazards should be mitigated expeditiously to prevent personal injury.

The entrance monument appeared to be in excellent condition. We observed only very minor mortar cracking, which should be repaired under operations.

High-Rock Ridge Road is responsibility of the community. We understand that Fauquier County. The footpath is approximately 6 feet wide and 530 linear feet tion. We observed one locations where the footpath asphalt was heaved by the should be mitigated expeditiously to prevent personal injury. We also observed n repair allowance to address these deficiencies.

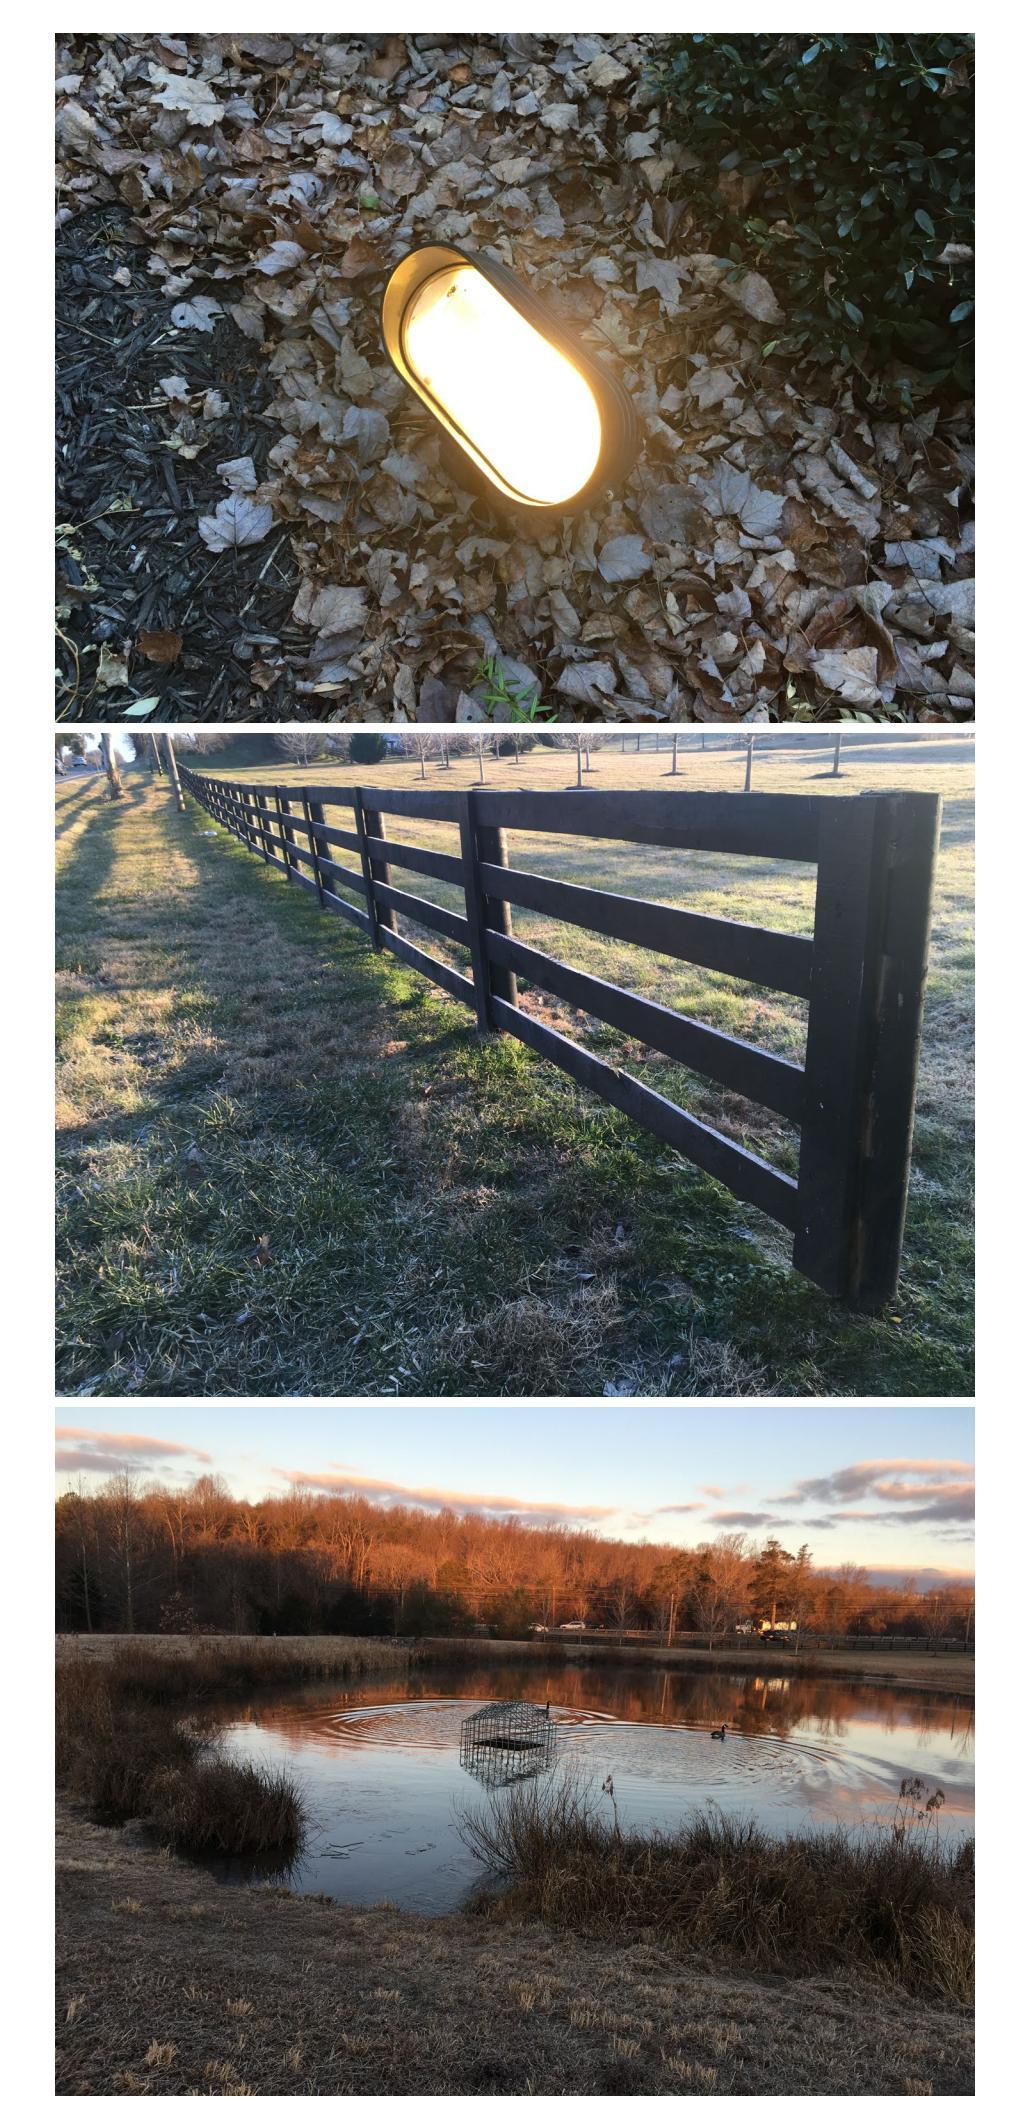
PHOTO #4 The monument halogen landscape light was functional, and we did not observe any deficiencies.

PHOTO #5 The old wood fencing along Lee Highway was replaced and stained in 2020 and was in excellent condition.

The two storm water management ponds appeared to be in good condition, and we did not observe any deficiencies.
